FATIGUE BEHAVIOUR OF A ROLLED AZ31 MAGNESIUM ALLOYS PREPARED BY EP AND BB CONDITIONS

Y. Fouad

Faculty of Engineering and Materials Science, German University in Cairo, Cairo.

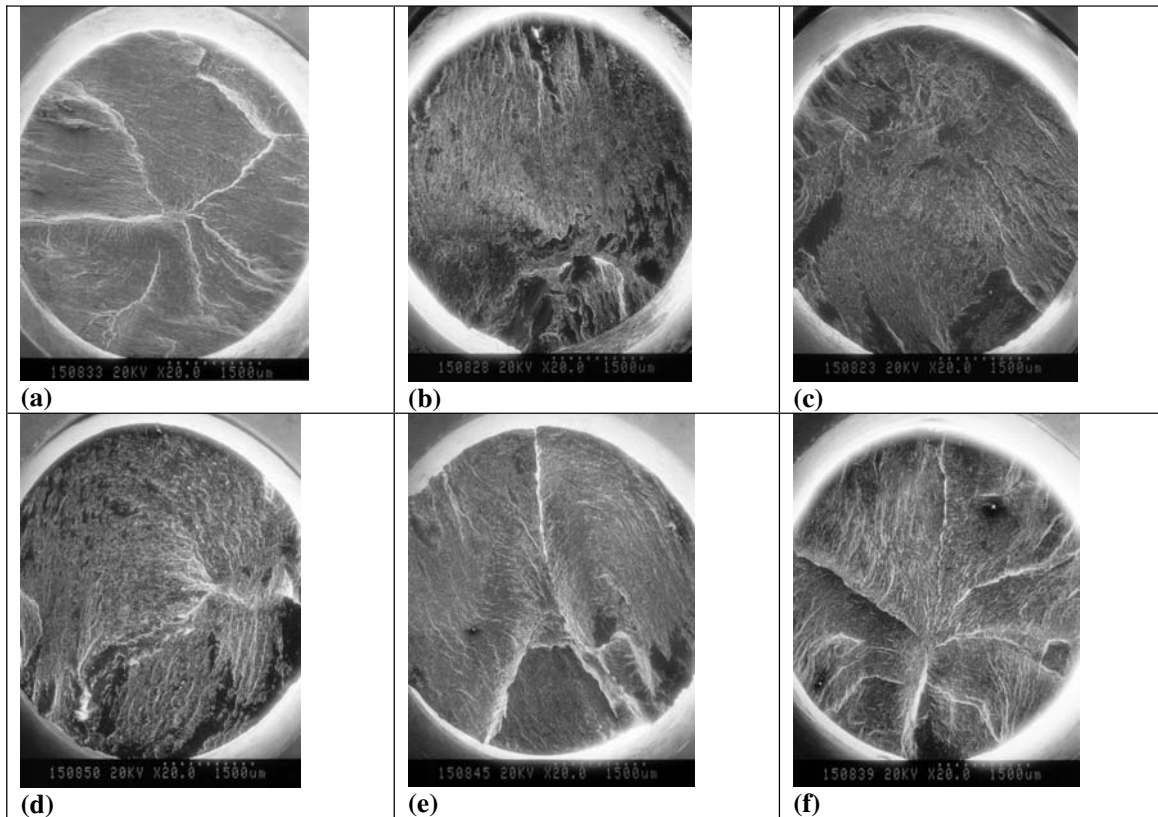
The fracture surface of AZ31 for EP condition and BB condition at different stress is shown in Fig.

4. Subsurface crack initiation occurred at applied stresses at 60 MPa. At BB condition but it can be seen for both 80 and 100 MPa stress for EP condition. The S-N diagram is shown in Fig. 2. It is well known that fatigue limit does not exist in non-ferrous alloys, thus fatigue tests were continued until 10^7 cycles. At EP condition $\sigma = 40$ MPa, fatigue failure did not occur, but non-propagating cracks were observed on the specimen surface. As can be seen in the figure, the present Mg alloy seems to possess a definite fatigue limit, which may be related to the existence of non-propagating cracks. The fracture mode depending

Fig.4. SEM micrographs showing fracture surfaces at difference stress for EP at (a) 60MPa; (b) 80 MPa; (c) 100 MPa and BB at (d) 60MPa; (e) 80 MPa; (f) 100 MPa.

on applied stress level, above 60 MPa cracks initiate at the surface (surface fracture), while below that stress at the interior of the specimen (subsurface fracture). Subsurface fracture is a very interesting finding, which has not been recognized in Mg alloys, for both EP and BB conditions.

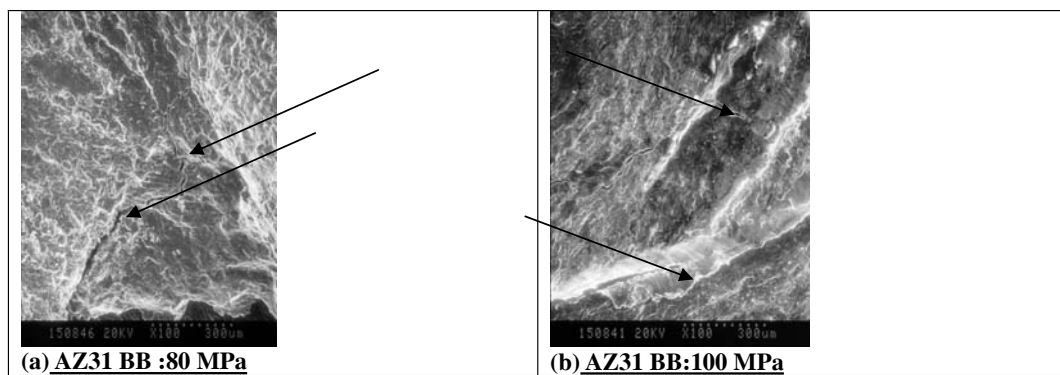
Fig. 5. SEM micrographs showing cracked surfaces at difference stress for BB at (a) 80MPa; (b) 100 MPa

The cracked line could be seen easily for higher stress for BB condition as fracture occurs in internal surface not at the outer surface as in the EP condition in Fig. 5.
