# FATIGUE BEHAVIOUR OF A ROLLED AZ31 MAGNESIUM ALLOYS PREPARED BY EP AND BB CONDITIONS

**Abstract:** Rotating bending fatigue tests have been performed using smooth specimens of a rolled AZ31 magnesium alloy in laboratory air at ambient temperature. Fatigue strength and characteristic was evaluated and fracture mechanism was discussed on the basis fracture surface analysis. Electrical polishing (EP) as well as deep rolling (ball burnishing (BB)) U-notched specimens were performed on two groups of samples, to evaluate optimum conditions for fatigue life. The microstructure and tensile properties of roll cast (RC) Mg- 3% Al- 1% Zn (AZ31) was investigated. The fatigue strength of 107 cycles around 100 MPa for deep rolling while it was around 40 MPa for Electrical polishing. It was very important to understand the effect of (ball burnishing (BB)) conditions on the hardness of the surface through to the core. The two procedures improved the fatigue performance, but better improve in results were found in ball burnishing. The growth of small cracks initiated at the surface coincided with the FCP characteristic after allowing for crack closure for large cracks, but the operative fracture

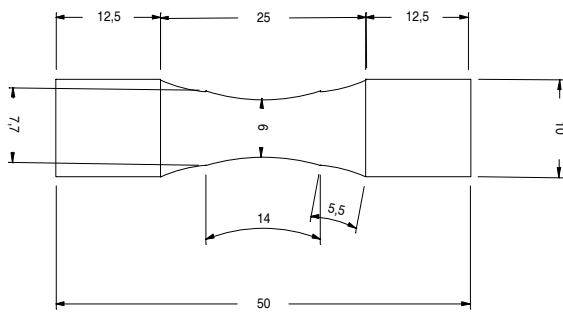
As shown in Fig. 1. Mechanical testing tensile and fatigue specimens with 5 mm diameter, 14 mm gauge length was machined from as-received so that their axis is parallel to the rolling direction. BB condition prepared with the following preparation condition on ECOROLL instrument using tool type (HG6) at 100 bar (246 N) with feed rate of 0.17 mm/min at 30 rpm.

**Fig. 1.** Shape and dimension of mechanical testing specimens

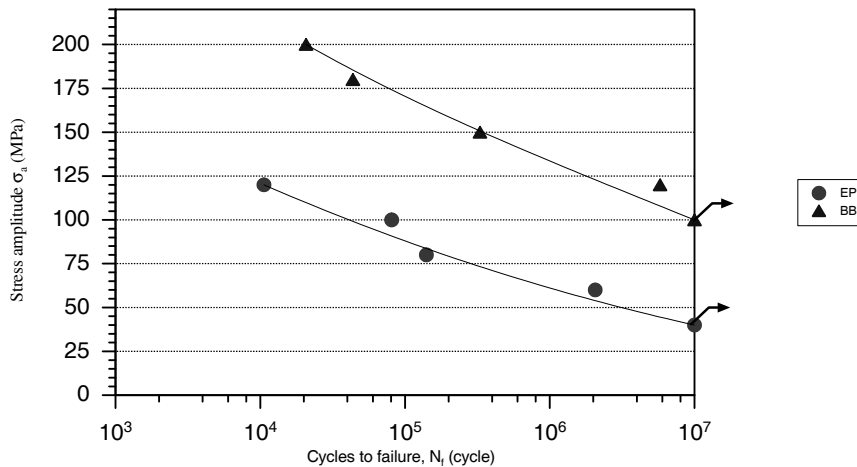
S/N curves for the EP and the BB specimens in laboratory at a stress ratio of -1 and frequency of 50 Hz (rolled magnesium alloy) in laboratory air is shown in Fig. 2. In this figure, for comparison purposes, the S–N curves of the EP and BB specimens are shown respectively. As seen from the figure, the fatigue life of the rolled magnesium alloy of EP specimen is relatively shorter than that of BB specimen. The extent bending in the S–N curve is gentler in the BB specimens than in the EP specimen. Next let us compare the S–N characteristics of the EP and BB specimens. There are great differences in the fatigue lives and in the fatigue limits, especially at higher stress amplitudes, there are differences in the fatigue lives.

Fig.2. S-N curve for rolled AZ31 at EP, BB conditions, rotating beam, R=-1, 50Hz.

4. Subsurface crack initiation occurred at applied stresses at 60 MPa. At BB condition but it can be seen for both 80 and 100 MPa stress for EP condition. The S-N diagram is shown in Fig. 2. It is well known that fatigue limit does not exist in non-ferrous alloys, thus fatigue tests were continued until  $10^7$  cycles. At EP condition  $\sigma = 40$  MPa, fatigue failure did not occur, but non-propagating cracks were observed on the specimen surface. As can be seen in the figure, the present Mg alloy seems to possess a definite fatigue limit, which may be related to the existence of non-propagating cracks. The fracture mode depending

1. Fatigue strength at  $10^7$  cycles was 100 MPa

for BB condition with the following preparation condition on ECOROLL instrument using tool type (HG6) at 100 bar (246 N) with feed rate of 0.17 mm/min at 30 rpm. While the fatigue strength at 10<sup>7</sup> cycles was 40 MPa for EP condition.

2. Fatigue lives and the fatigue limit of BB specimens were higher than those of EP specimens with similar profiles.
3. Electrical polishing and ball burnishing preparation are very sensitive to working procedure of choosing temperature for EP or in choosing (Feed, Speed and tool head) for BB condition. After many trails to find out the good combination of the three parameters.
4. As a result of crack initiate from the surface for EP condition it fails under lower stress than in BB condition which crack initiate internally ( as surface treated by BB).
5. It could be investigate the best condition of BB by examine the surface up to 500 μm for microhardness value, to choice best values for BB treatment.

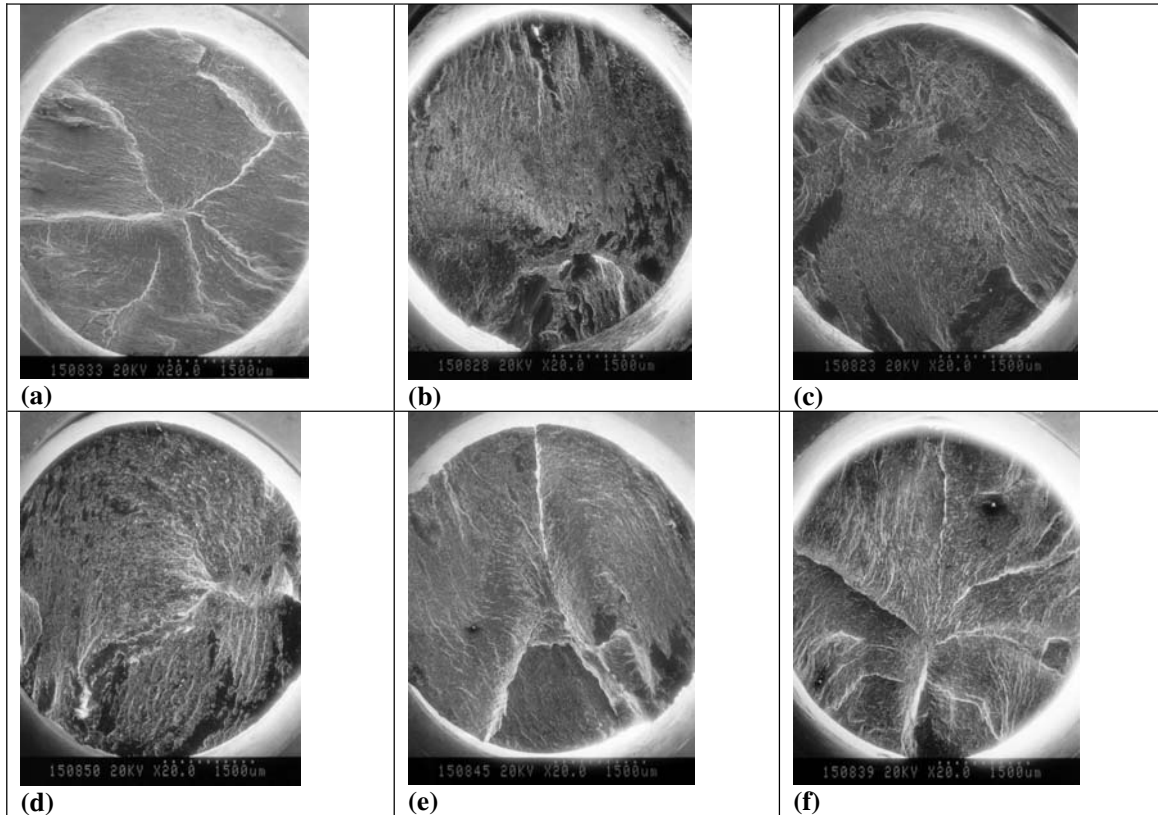
The fracture surface of AZ31 for EP condition and BB condition at different stress is shown in Fig.

**Fig.4.** SEM micrographs showing fracture surfaces at difference stress for EP at (a) 60MPa; (b) 80 MPa; (c) 100 MPa and BB at (d) 60MPa; (e) 80 MPa; (f) 100 MPa.

on applied stress level, above 60 MPa cracks initiate at the surface (surface fracture), while below that stress at the interior of the specimen (subsurface fracture). Subsurface fracture is a very interesting finding, which has not been recognized in Mg alloys, for both EP and BB conditions.
